Portage Creek Sediment Remediation Project Kalamazoo, Michigan

Pre-Sediment Removal Structure Feature Assessment Removal Areas SA5-A and SA5-B

F&V Project Number: 809930 August, 2012

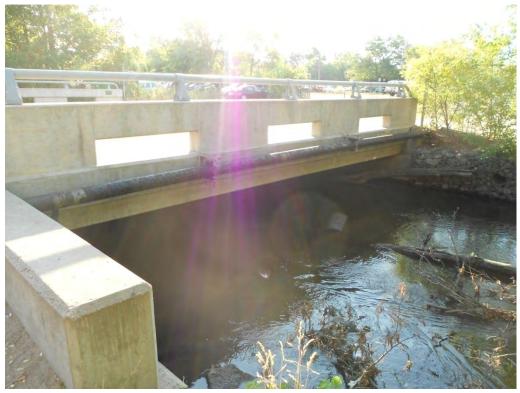
Elevation view of the structure

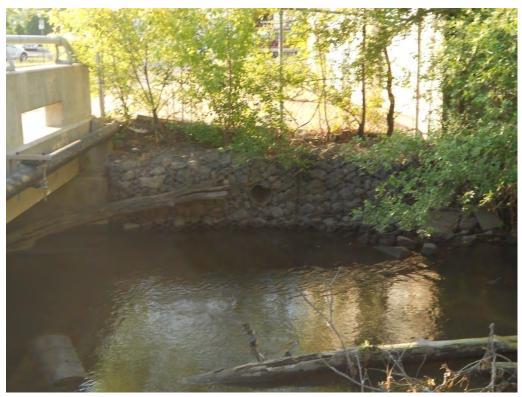
• Gabion baskets support the adjacent banks. They are in fair condition. There is a 12" CMP outlet through the southeast and northeast. The gabion basket in the southwest is failing into the channel. The northwest and northeast gabions are overgrown.

Gabion baskets in the southeast

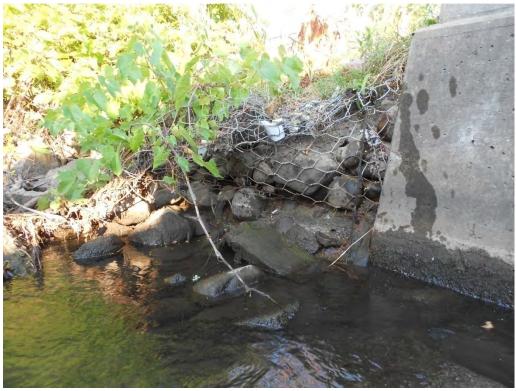
Failing gabion basket

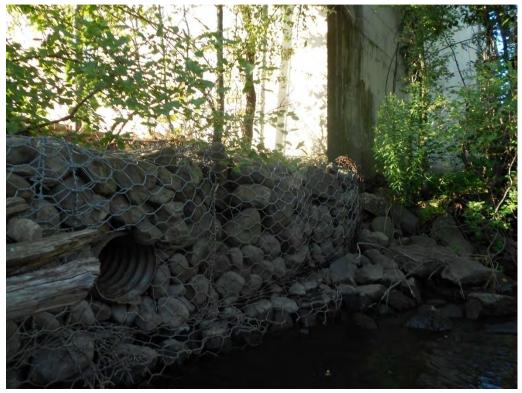
Gabion baskets in the southeast

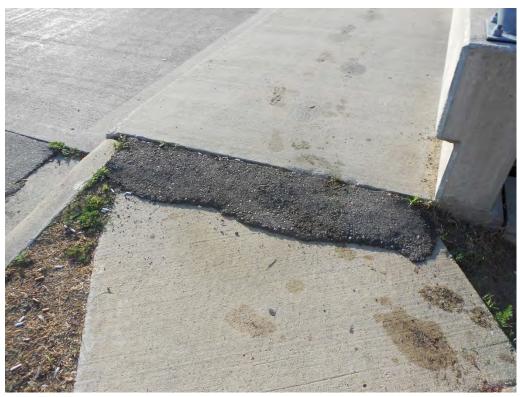
- There is a gas main supported along the south fascia and water main on the north fascia. There is an overhead crossing over the north side of the structure.
- Approach sidewalks have settled ~2.5" to 4" with asphalt wedging placed to mitigate settlement.
- The asphalt approach pavement has moderate cracking. Minor spalling was noted along the reference lines. Asphalt wedging has been placed at the structure to mitigate settlement.
- The concrete deck has ~4 lines of moderate to severe longitudinal cracking.
- Minor spalling was noted in the center of the south sidewalk.
- Grout forms were left in place between concrete box beams.
- Concrete slope paving has failed on the east side and is mostly failed on the west side (~5' slab).
- According to the bridge plans, there is an abandoned underground sanitary sewer crossing just south (upstream) of the structure.

Asphalt wedging placed to mitigate approach sidewalk settlement

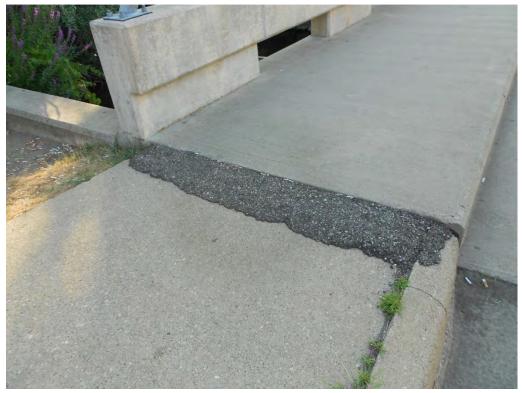
Asphalt wedging placed to mitigate approach sidewalk settlement

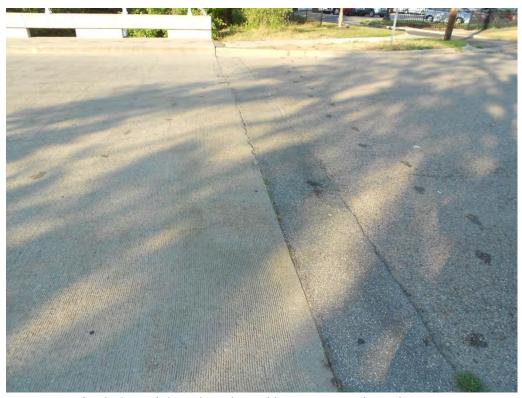
Asphalt wedging placed to mitigate approach settlement

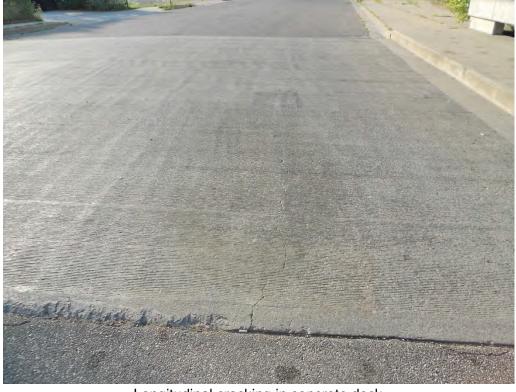
Longitudinal cracking in concrete deck

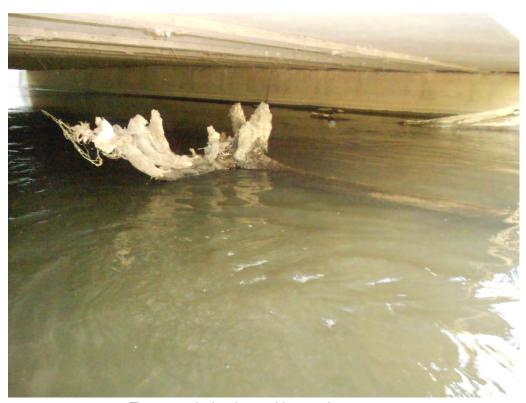
Tree caught in channel beneath structure

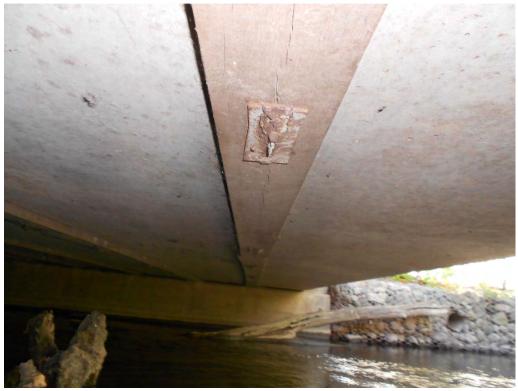
Grout forming left in place between box beams

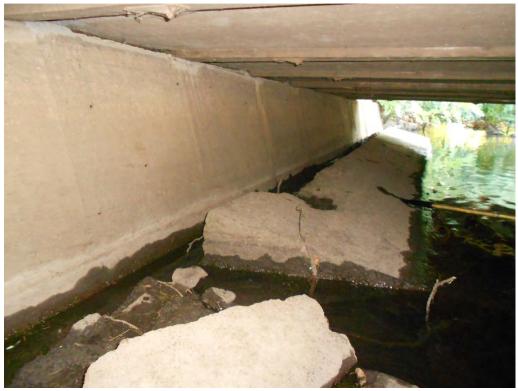
Failing concrete slope paving beneath the structure

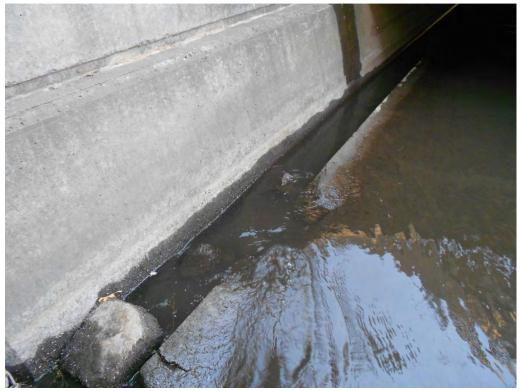
Failing concrete slope paving beneath the structure

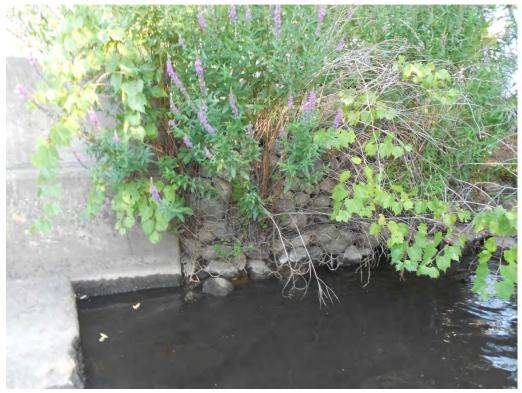
Overgrown gabion basket in northwest

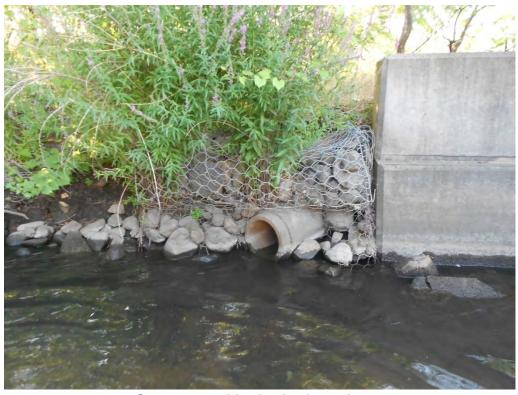
Overgrown gabion basket in northeast

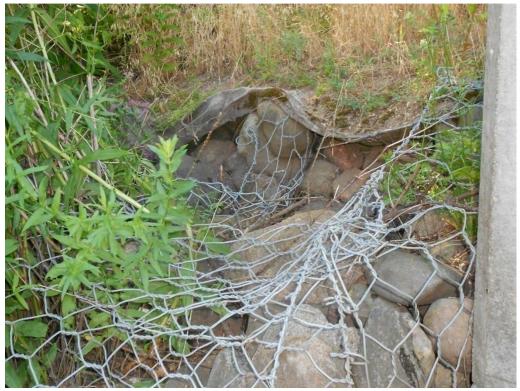
Failing gabion basket in the northeast

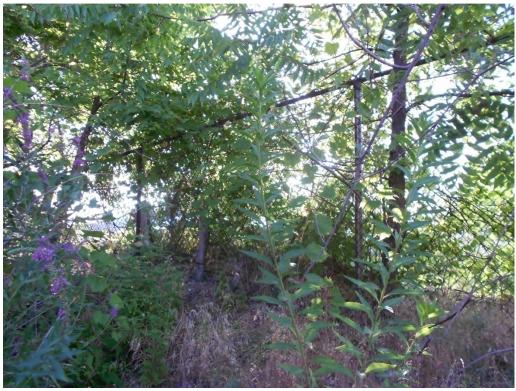
Overgrown fencing

• Remove and replace fencing in kind as required.

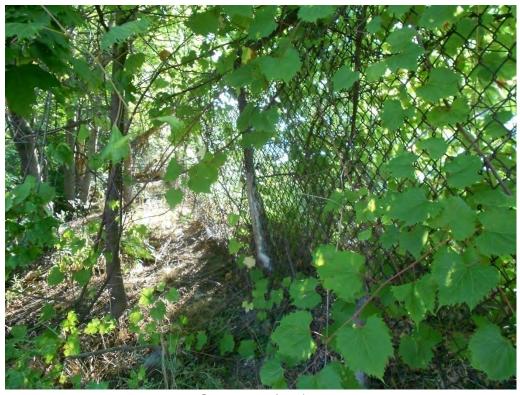
Overgrown fencing

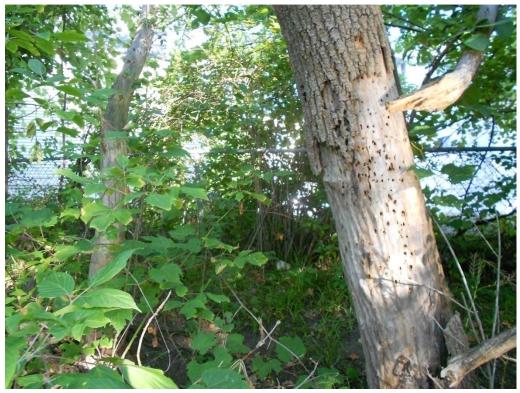
Overgrown fencing

• Remove and replace fencing in kind as required.

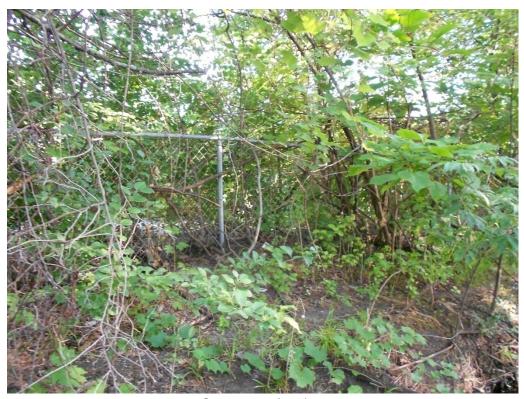
Overgrown fencing

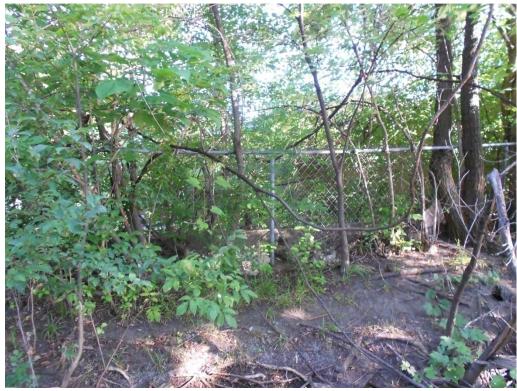
Overgrown fencing

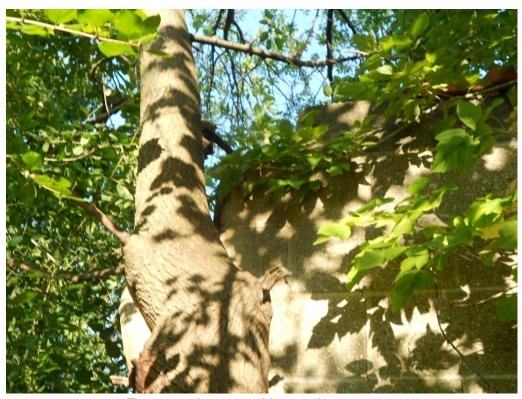
Tree growth encroaching on the structure

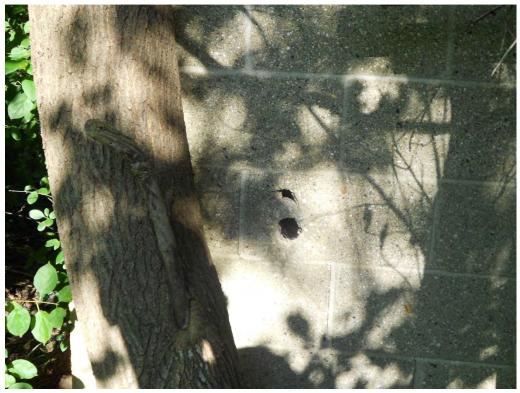
Penetration in CMU wall

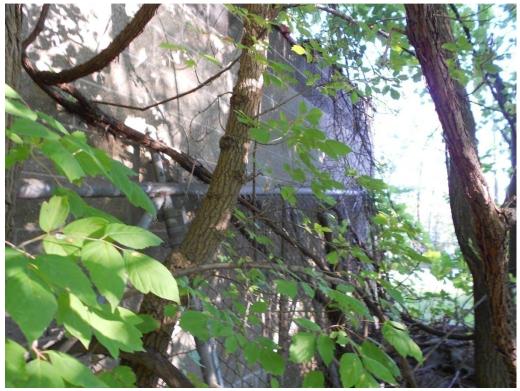
Overgrown wall and fencing

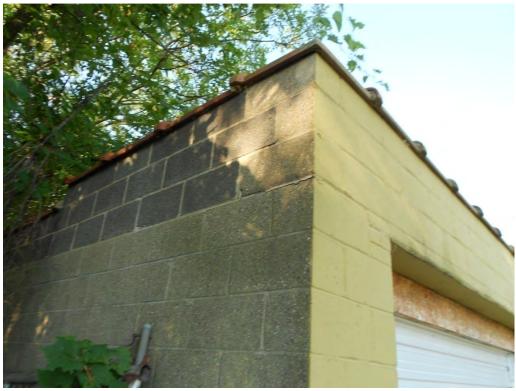
Minor to moderate step cracking was noted in exposed areas of CMU walls.

Step cracking in corner of building

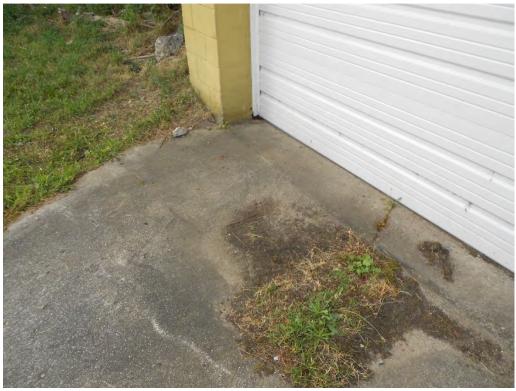
Settlement of concrete approach in northeast

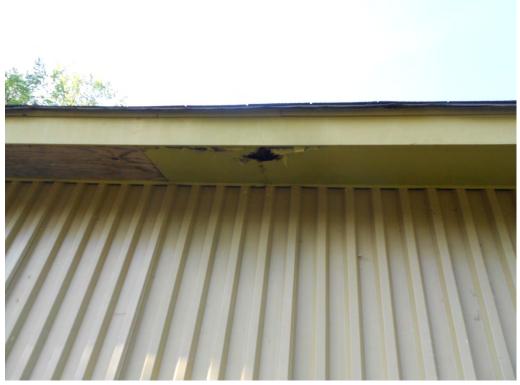
Hole in soffit

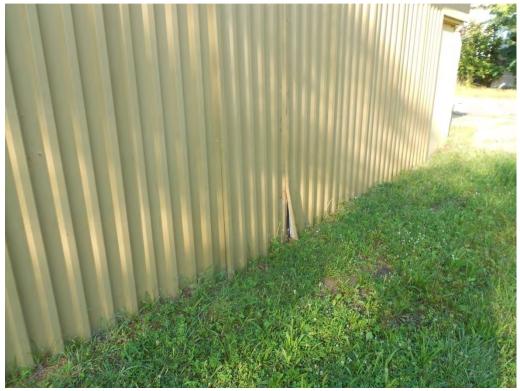
Damaged siding on north wall of building

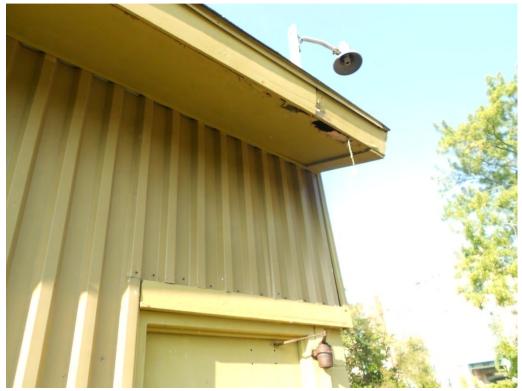
Holes in soffit of building

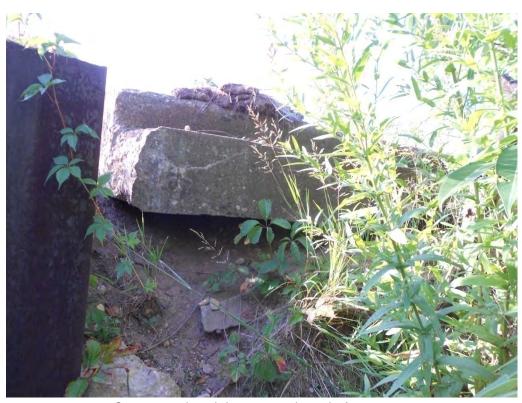
Severe undermining on north end of concrete

It is recommended that the property owner be contacted to determine whether the structure can be removed and either eliminated or replaced in kind to facilitate sediment removal operations.

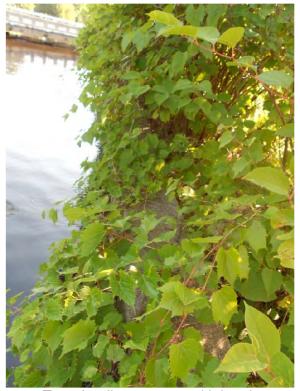
Top of wall overgrown with brush

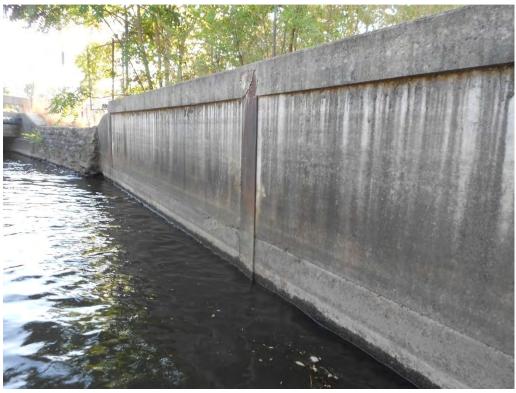
View of northern area of wall

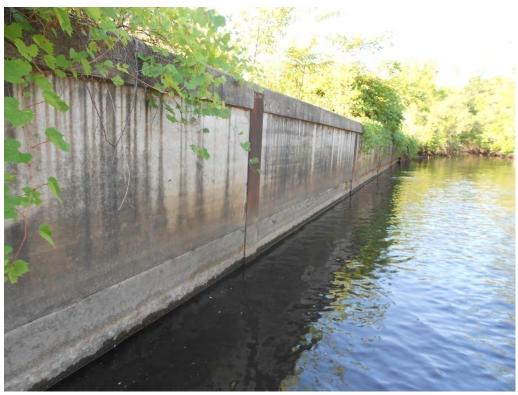
View of wall looking south

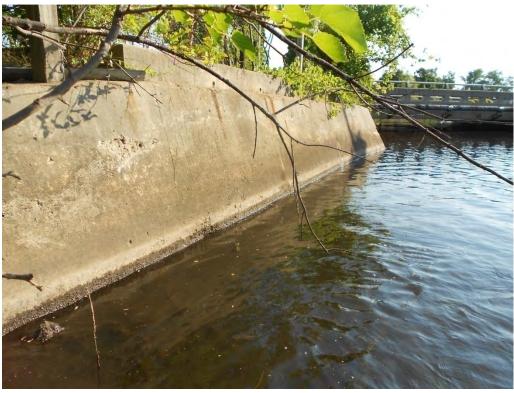
View of wall looking north

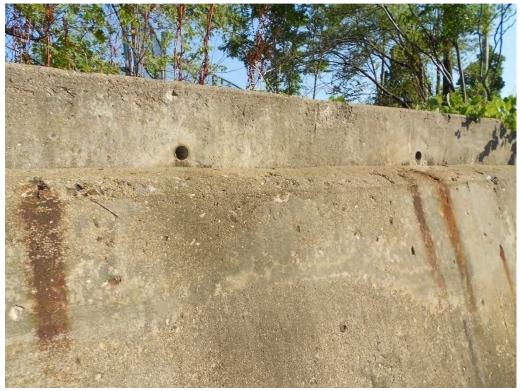
Curb area with circular penetrations

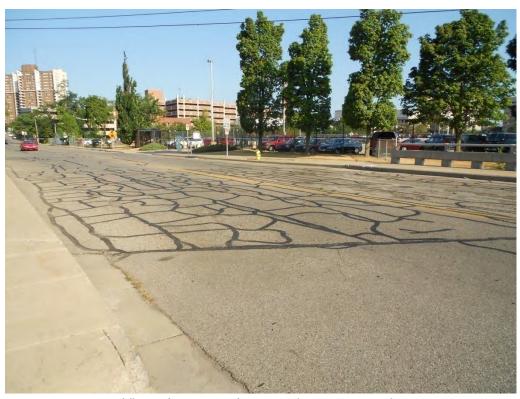
View of structure from southeast approach

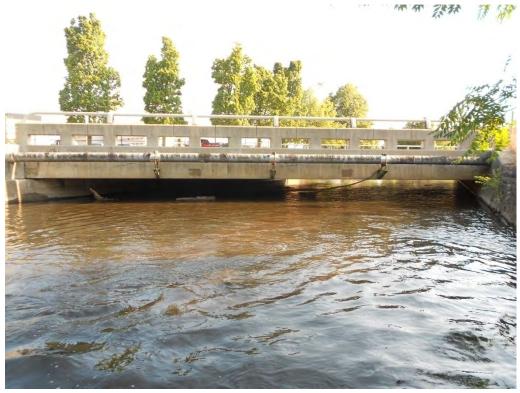
Elevation view of structure

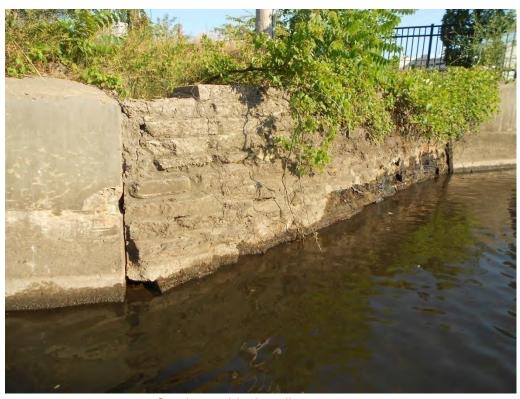
- The block wall in the southeast is overgrown with cracking along the joint with the adjacent concrete wall. There is a sink hole behind the wall in the southeast at the south end. It is covered with concrete at the surface but has a void at the waterline. Block walls in the northeast and northwest are in fair condition with scattered vegetation growth through cracks and joints.

Southwest block wall overgrown

Because the structure is supported on deep foundations, it is less susceptible to vibration
and settlement than structures on shallow foundations. However, the block walls are
susceptible. Therefore, a minimum 4' clearance is recommended for the bridge and 6' for
the block walls. Gaps between the cofferdam and block walls should be sealed with sand
bags to avoid disturbing them.

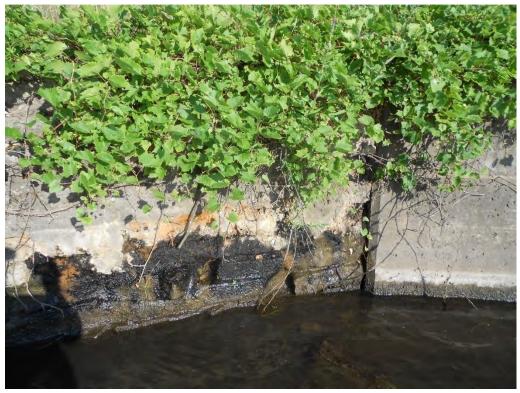
Gaps in blocks along waterline and joint to abutment

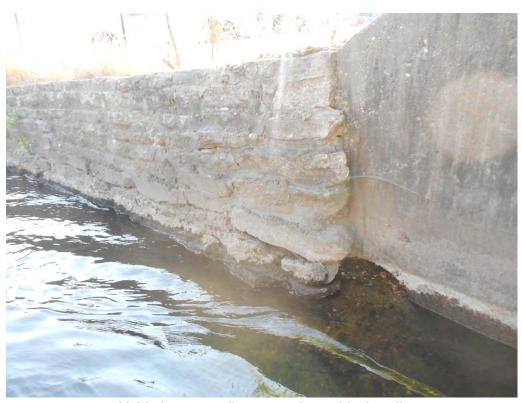
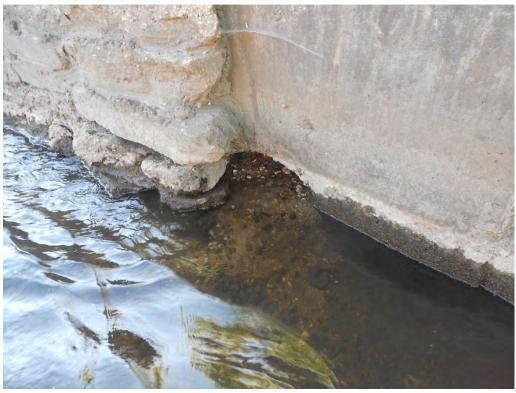
Void along waterline at southeast block wall

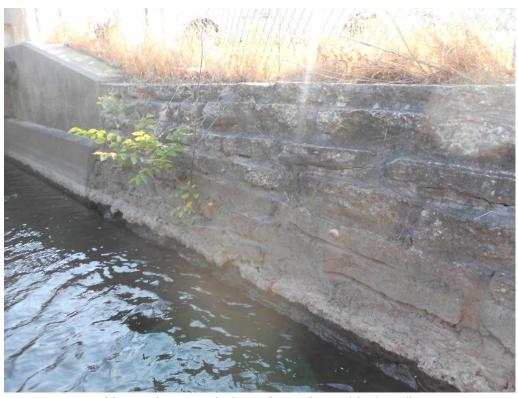
Vegetation growth through southeast block wall

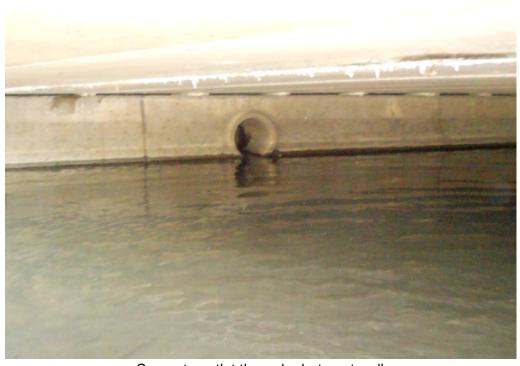
- There is a concrete outlet through the face of the abutment.
- The asphalt wearing surface has severe cracking and spalling, which is partially sealed and cold patched.

Concrete outlet through abutment wall

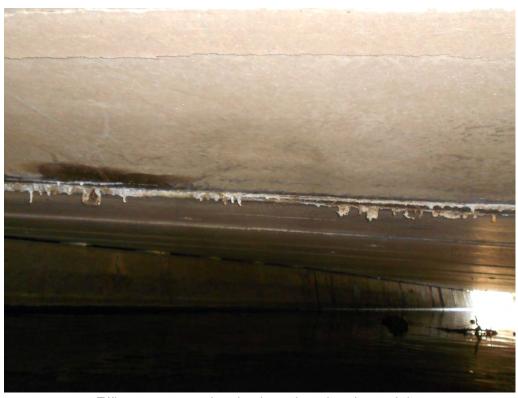
- There is a gas main supported along the south fascia and water main along the north.
- Hairline horizontal/map cracking was noted in the box beam fascias. Efflorescence and stalactites were noted along several box beam joints.

Efflorescence and stalactites along box beam joint

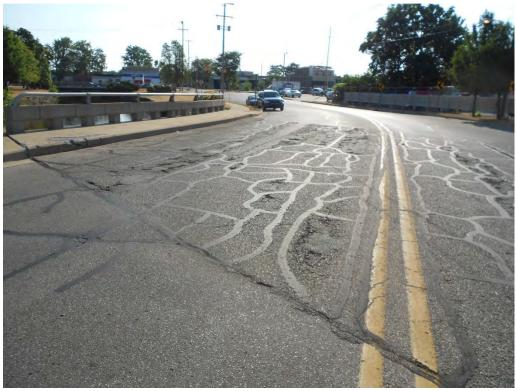
Cracking and spalling in asphalt surface

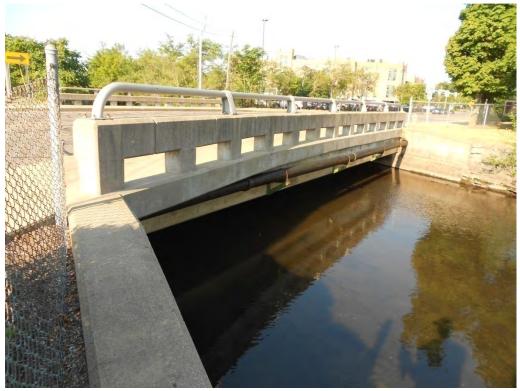
Water main supported along north fascia

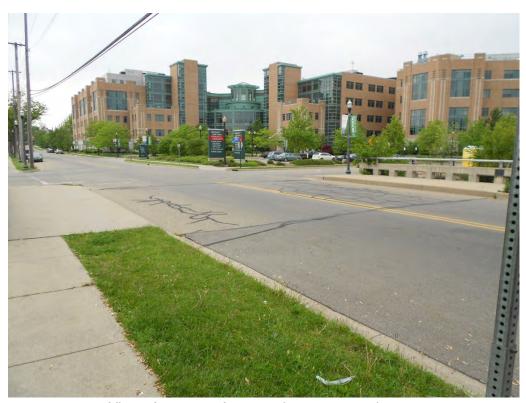
View of structure from southeast approach area

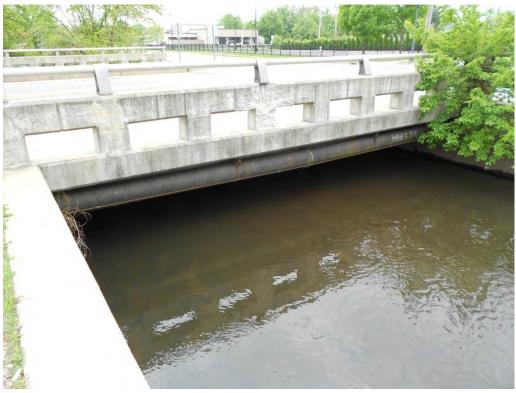
Elevation view of structure

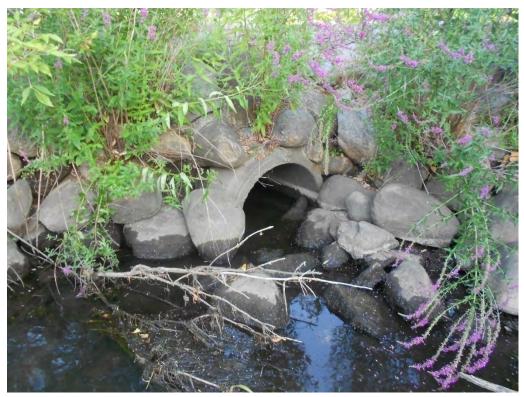
View of outlet from the channel area

• We understand that sediment removal is not planned in area SA5-B. However, if plans change, the outlet should be isolated with a cofferdam to allow for dewatering. The cofferdam should be installed with a minimum 2' clearance to the outlet.

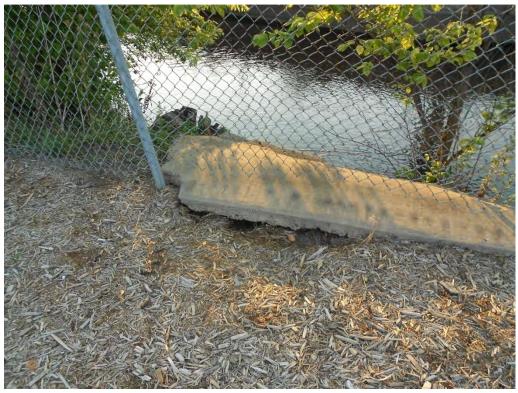
Undermined slope paving at the top of bank

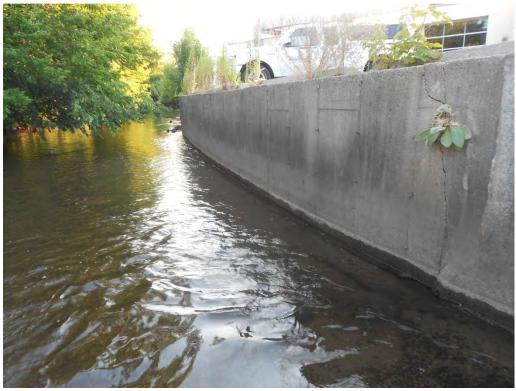
View of the wall looking north from the south end

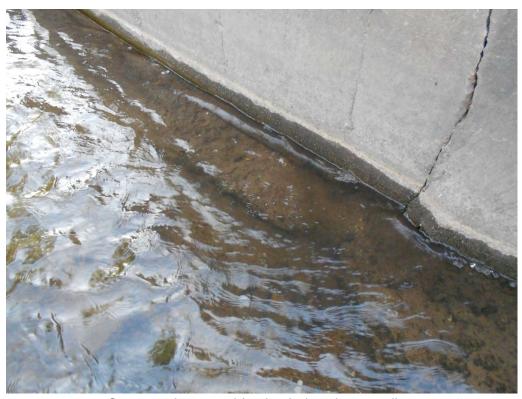
• There is a severe vertical crack 5' north of the south end of wall and possible exposed footing with slight undermining.

Suspected exposed footing below the waterline

- We understand that sediment removal is not planned in area SA5-B. However, if plans change, a minimum 4' clearance should be maintained with the wall. It may be possible to install sheet piling parallel to the wall with bracing between during sediment removal, especially if equipment is to be placed behind the wall during the work.
- It is recommended that the sanitary manholes on each side of the channel be opened to establish the line and grade of the sewer as it crosses beneath the channel. Maintain a minimum 6' clearance to the sewer if sediment removal is required.

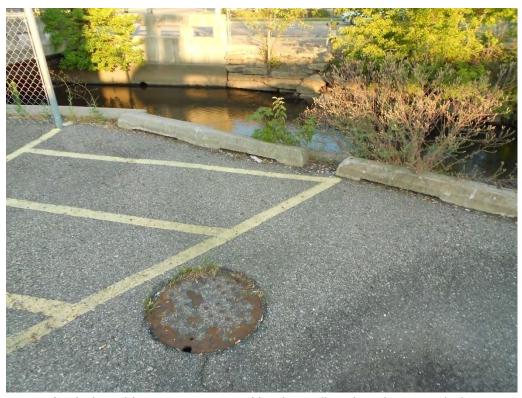
- Form ties are exposed and corroded along the face of wall.
- Moderate vertical cracking was noted 9' and 12' north of the south end of wall.
- The asphalt parking lot has moderate to severe cracking throughout with vegetation growth through the cracks.

Asphalt parking area supported by the wall and sanitary manhole

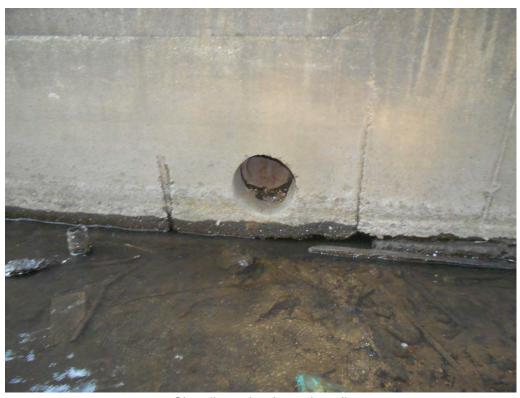
- There are several outlets through the face of wall. An area of suspected footing exposure was noted at the first outlet from the south, a 10" clay tile. Moderate cracking was noted in the tile. Severe vertical cracking was noted at the 2nd outlet from the south, an 8-inch clay tile. A 4" outlet is 3rd from south, located just above the waterline.

Clay tile outlet through wall

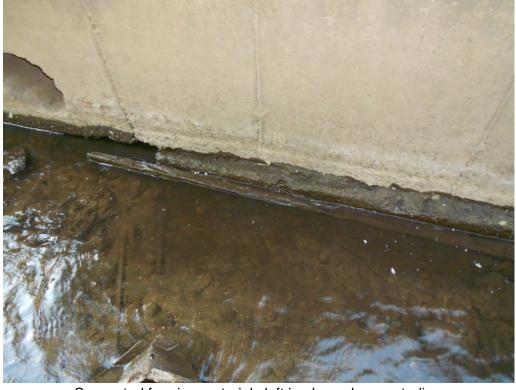
Suspected forming materials left in place along waterline

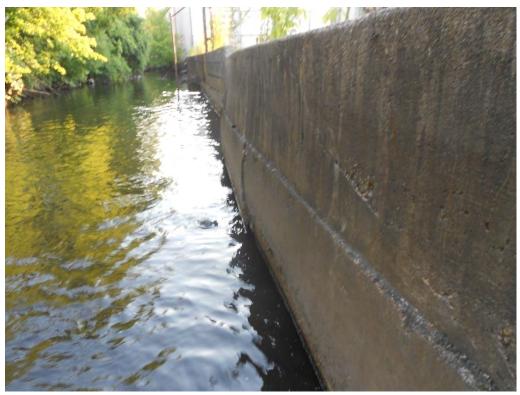
View of wall looking north

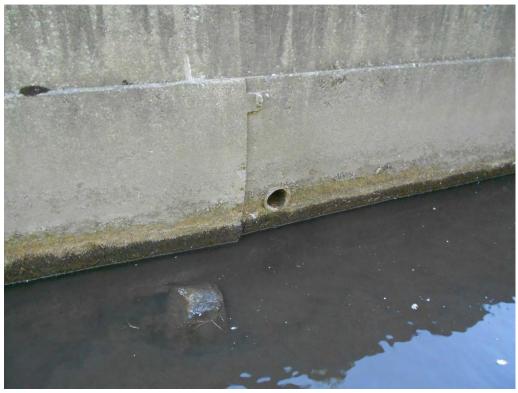
Outlet through wall just above waterline

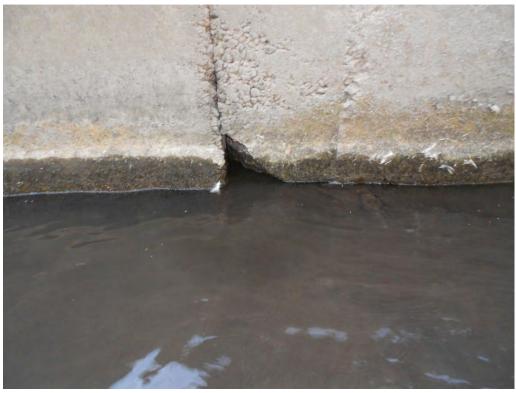
- There is severe bowing in the wall between the 3rd and 4th outlets from the south, apparently from form deflection during construction. There is a cold joint with spalling and honeycombing at the north end of the bowing.

Honeycombing and spalling along cold joint in wall at waterline

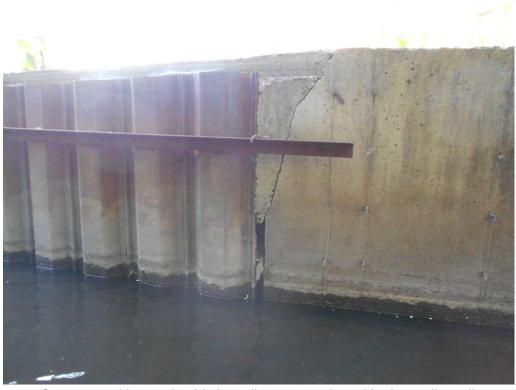
- · Scattered honeycombing was noted in the face of wall.
- There is an offset approximately 1.5" 19' north of the chain link fence.
- There is a 2.5"-3" gap at the north end of the concrete wall with voids approximately 18" deep and a moderate vertical crack at the joint with the adjacent sheet pile wall.

Severe cracking and voids in wall at connection with sheet pile wall

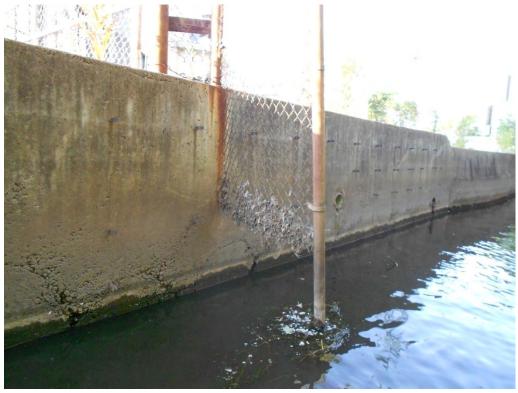
• Significant channel debris was noted on the fence fabric.

Debris on fence fabric above waterline

• Remove and replace the fence in kind if required.

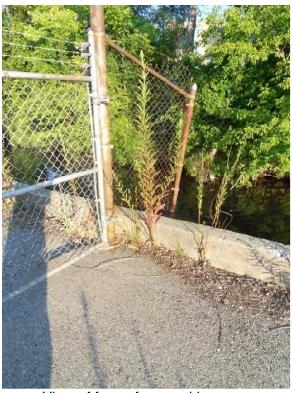
View of fence from parking area

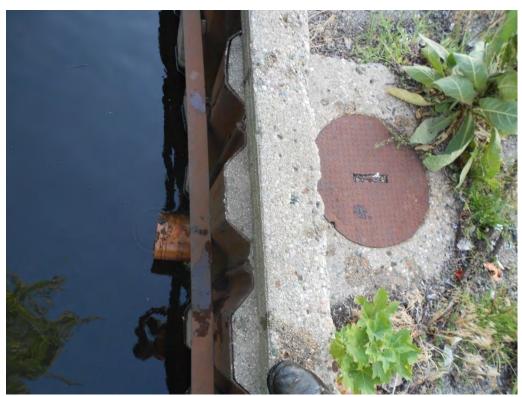
View of clay tile outlet from top of wall

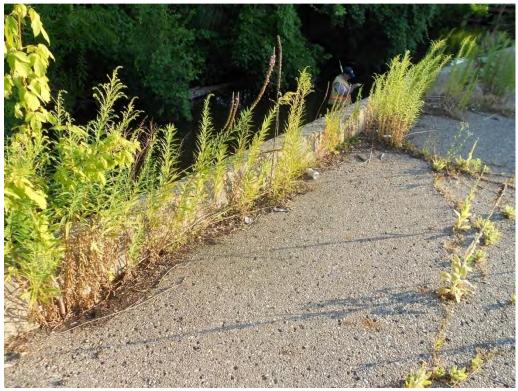
Cracking with vegetation in asphalt parking area

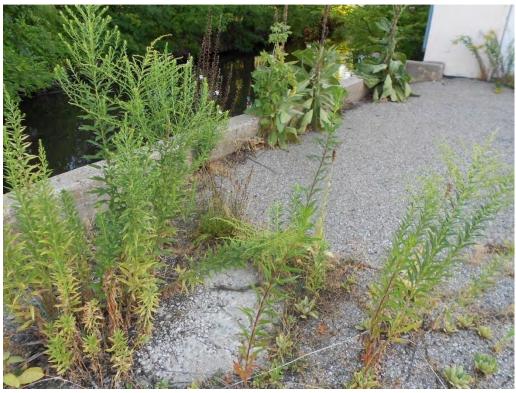
Cracking with vegetation in asphalt parking area

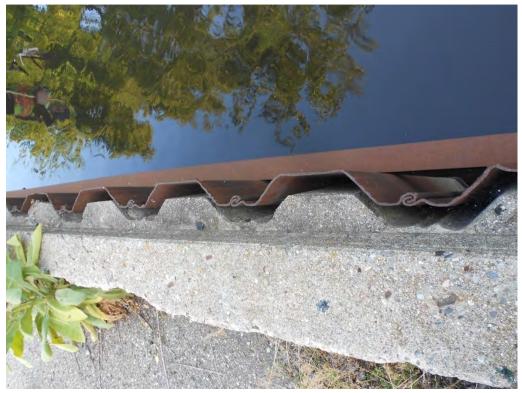
- There is an 8" clay tile outlet 11' north of the south end of the wall with moderate cracking along the invert.
- There is a sink hole in the asphalt behind the wall at the 8" clay outlet.
- The asphalt pavement has cracking with vegetation throughout.
- The steel angle support placed horizontally along the wall has moderate to severe surface corrosion and bowing.
- The concrete curb has minor to moderate vertical cracking at ~10' spacing.
- The sheet pile has separated from the concrete curb approximately 1-2".

Sheet pile separation from curb

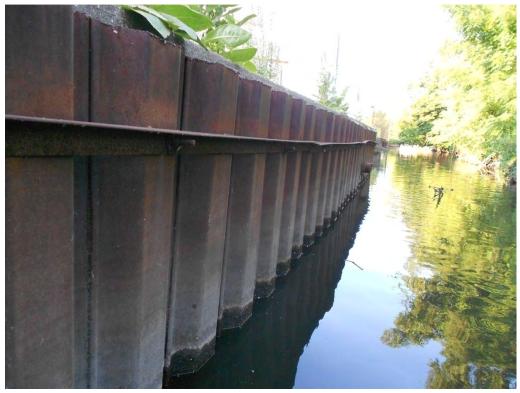
View of wall looking south

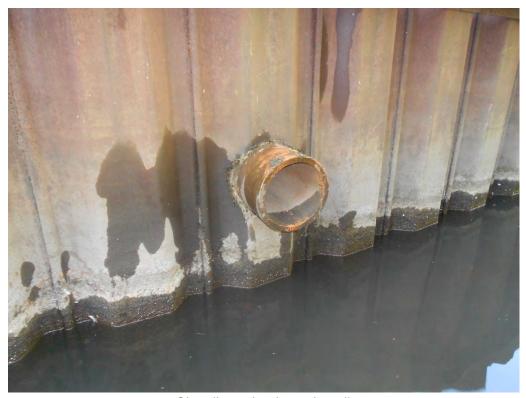
Clay tile outlet through wall

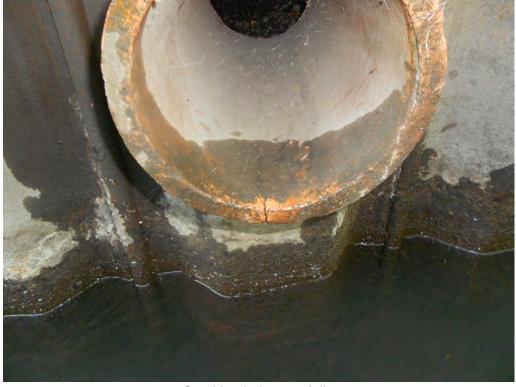
Cracking in invert of tile

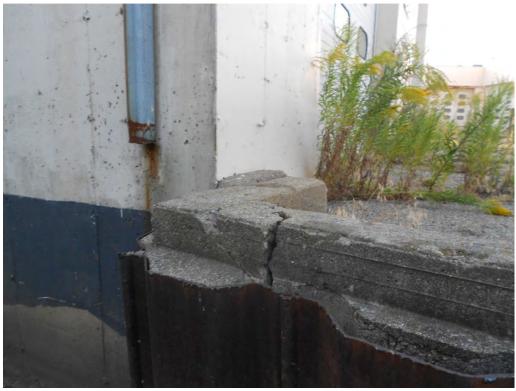
North end of wall adjacent to building

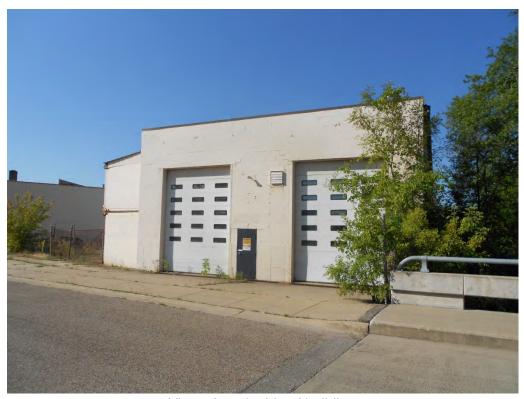
View of north side of building

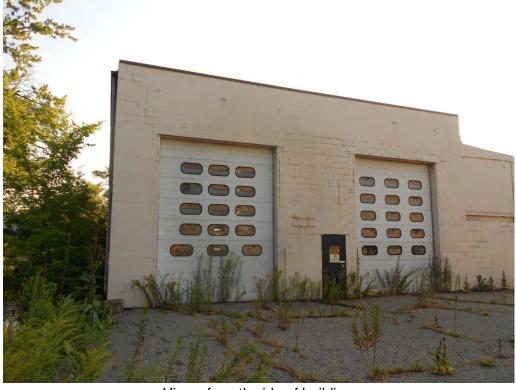
View of south side of building

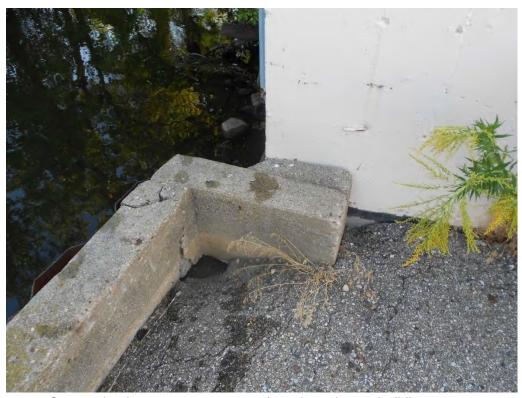
Connection between concrete curb and southwest building corner

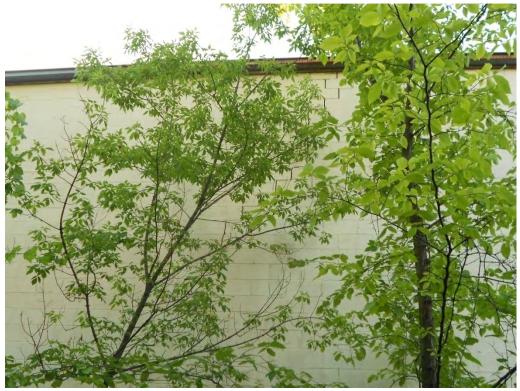
- Heavy tree and brush growth was noted along the building where the bank is intact.
- There is severe step cracking in the west wall. The south half of the west wall is partially
 obscured by trees. The cracking appears to be approximately 1" wide and extends into the
 concrete foundation wall.

West wall obscured by tree growth

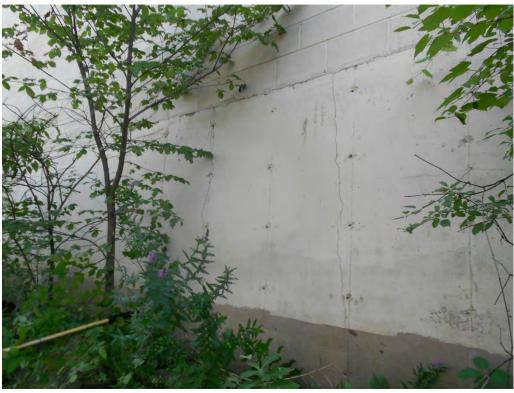
- Scattered moderate cracking (~4 total) was noted in the concrete foundation wall around the center of the wall.
- Minor step cracking was noted in the north end of the west wall.

Cracking in west foundation wall

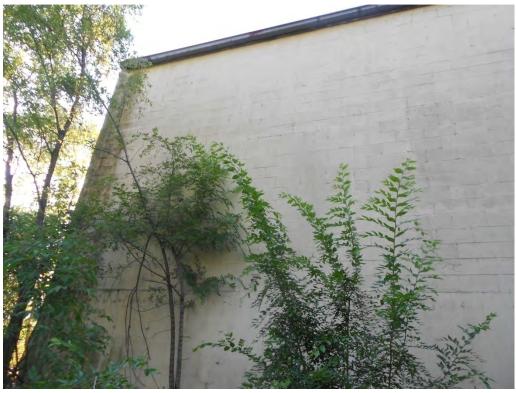
Step cracking in north end of west wall

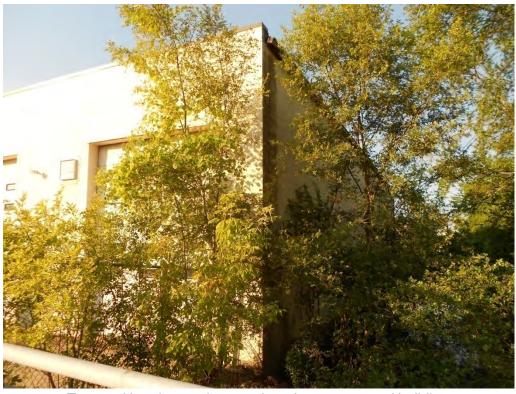
Tree and brush growth around northwest corner of building
